2017 Bill Terrell Conservation Grant Report: Coastal Shorebird Management

Activity 1: Butler Island water control structures for shorebird habitat management

Activity 2: Predator Management at key beach nesting bird sites.

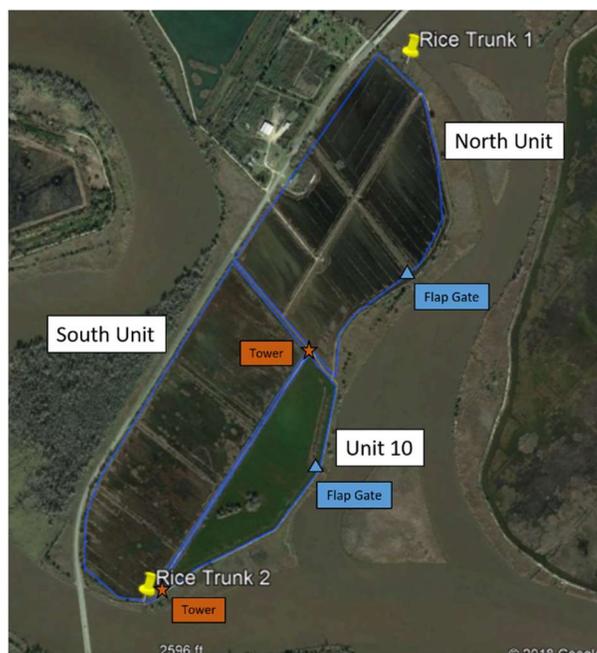
Funds from this grant were used to install two rice trunk water control structures, shown in Figure 1. Rice Trunk 1 was installed prior to the monitoring period on March 14, 2018, and was used to control water levels in the North Unit. The two flap gates along the eastern side of the system are also used by managers to control water levels in the North Unit and in Unit 10, respectively. Rice Trunk 2 was under construction for much of the survey period, resulting in altered hydrology that was not conducive to the creation of shorebird habitat. However, by June 21, 2018, Rice Trunk 2 installation was finalized and it was functional by August of that year (Figure 2).

During surveys, three independent units were identified. These units had variable depths and vegetation characteristics, primarily due to historic separations between subunits, as seen in the Figure 1. However, these remnant dikes are no longer sufficient to maintain separation, and management to influence water levels impacts all subunits with each of three, larger independent units. Therefore, for the purposes of monitoring, we chose to treat the Butler Island system as three units: the North Unit, Unit 10, and the South Unit.

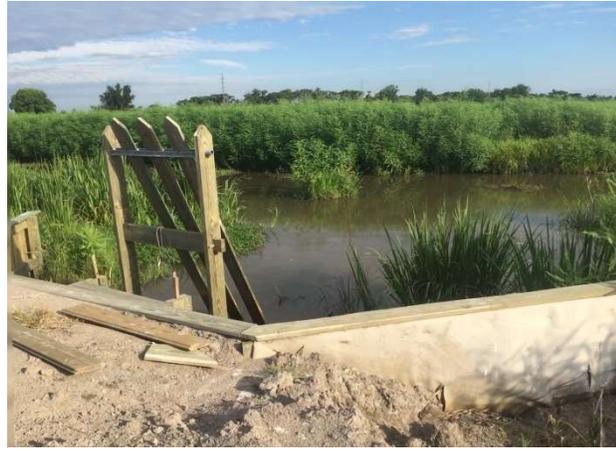
Figure 2 Rice Trunk 2, installed and functioning by August 1, 2019.

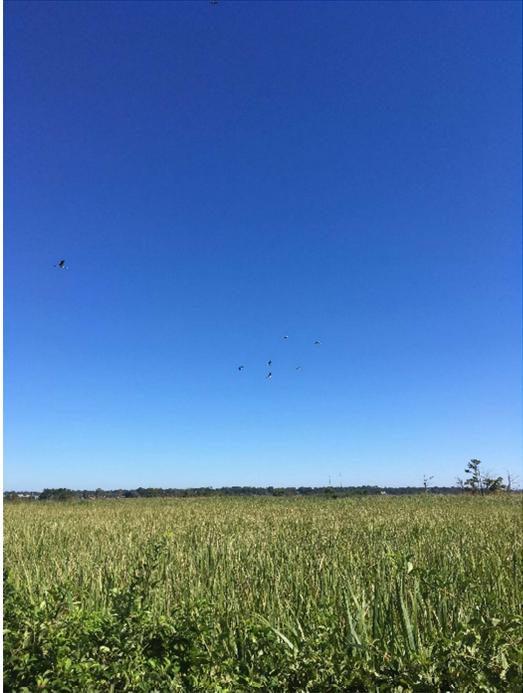
Figure 4 Dense cutgrass dominates significant parts of Unit 10, Butler Impoundments at the Altamaha WMA, Georgia.

Throughout the survey period, the North Unit held deep water and much of the lower areas were heavily vegetated with dense rye cutgrass (*Leersia oryzoides*) and sesbania (*Sesbania herbacea*) stands (Figure 4). There was only one survey when shorebirds were recorded using this unit (2 Lesser Yellowlegs), although there were other wading birds and waterfowl often observed. While some vegetation is important to provide structure, refuge and habitat for invertebrates which provide food for shorebirds and other waterfowl (Helmert 1992), high density vegetation dominated this unit after water levels were lowered to install the rice trunk. High water levels are often an important control of vegetation, but the combination of high water and dense vegetation left very little available habitat for shorebirds during this survey period. However, management is ongoing, and with the additional control provided by the newly installed rice trunk, this unit will be able to provide shorebird habitat in the future.

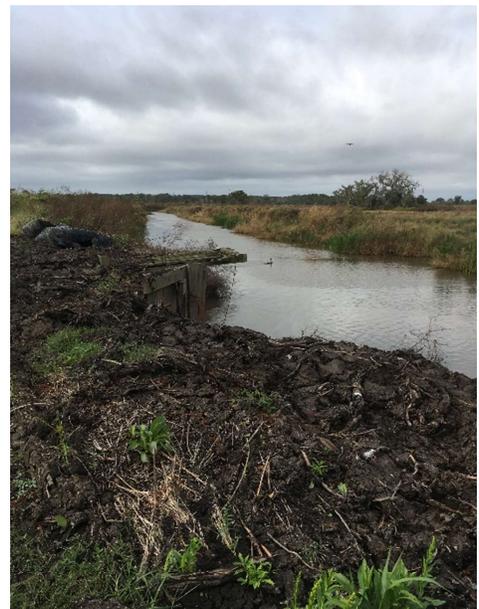
Figure 5 Water flap gate on Eastern side of North Unit, showing damage from Hurricane Michael, resulting in high water levels.

Both Hurricane Irma (September 2017) and Hurricane Michael (October 2018), caused significant damage to the Butler Island Impoundment system, including breaching the eastern wall (Figure 5). Despite the rice trunk installations, water levels were difficult to manipulate because extreme tides continued to overtop these structures. Perimeter dike work to repair this damage was ongoing throughout the survey period and completed in late spring of 2020 (Robert Horan, pers. comm). Ongoing challenges to control vegetation continue, which were exacerbated with altering the hydrology of the impoundments to allow for the installation and repair work. To date, managers

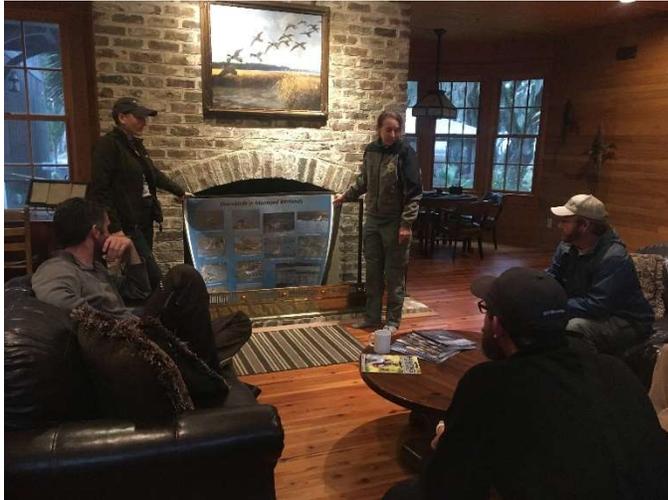
Figure 6 During an impoundment managers' workshop, participants discuss strategies to provide shorebird habitat.
